# Evaluation of River Hydromorphology Using the Morphological Quality Index (MQI): A Case Study of the Megun–Fasham River Section

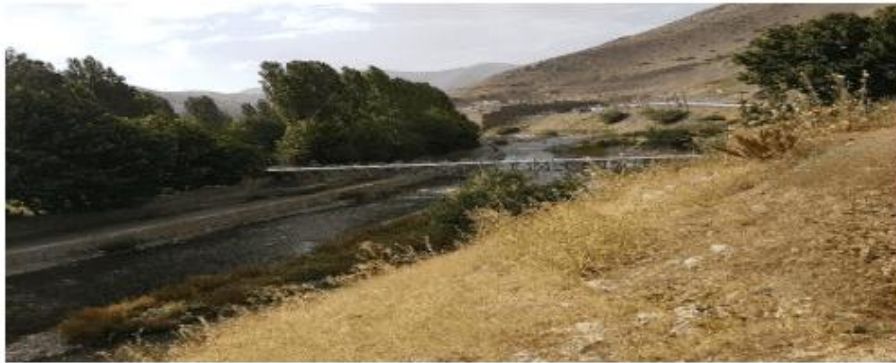
**Figure 2.** Existence of transverse structures on the river in interval 1

reason for the poor condition must stem from the parameters of the cross-banks, flow variability and depth variance. Its morphology is in some parts of the cascade, rapid and rising waters (Figures 2 and 3).

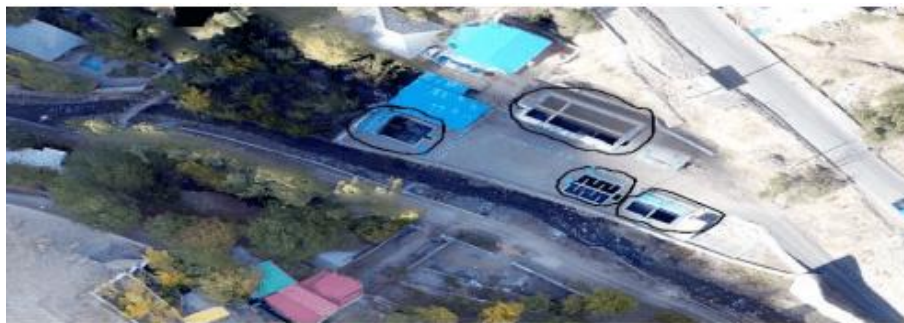
**Figure 3.** Existence of pools around the river in interval 1.

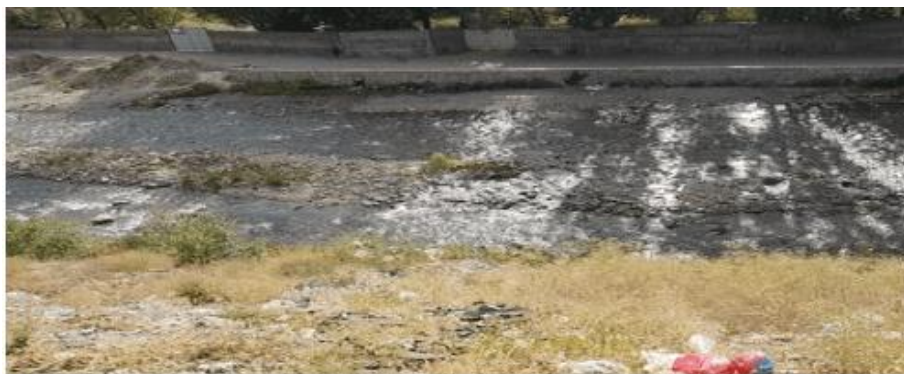
**Figure 4.** Existence of longitudinal barriers within the river channel in interval 2.

This period has also had changes due to its proximity to the surrounding settlements, which include 1. Change of use and new constructions around the river, 2. Creation of artificial canals and withdrawal of water from the river, including human interventions in the riverbed (Figures 4 and 5).

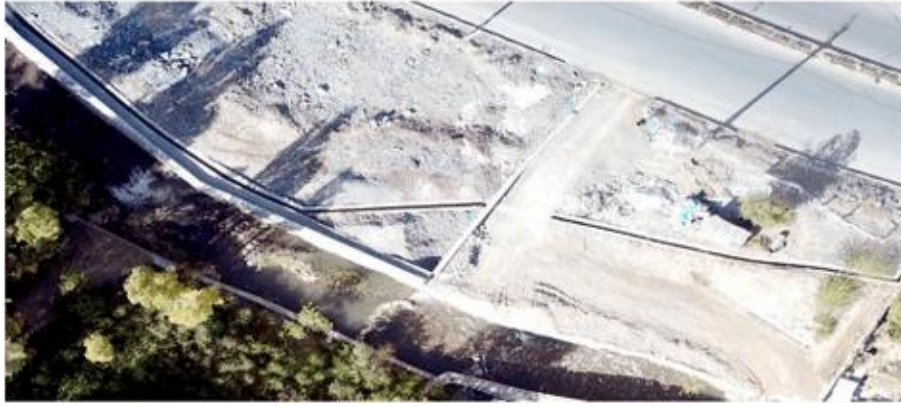
**Figure 5.** Existence of wooden barriers inside the canal and steep slope of the riverbank.

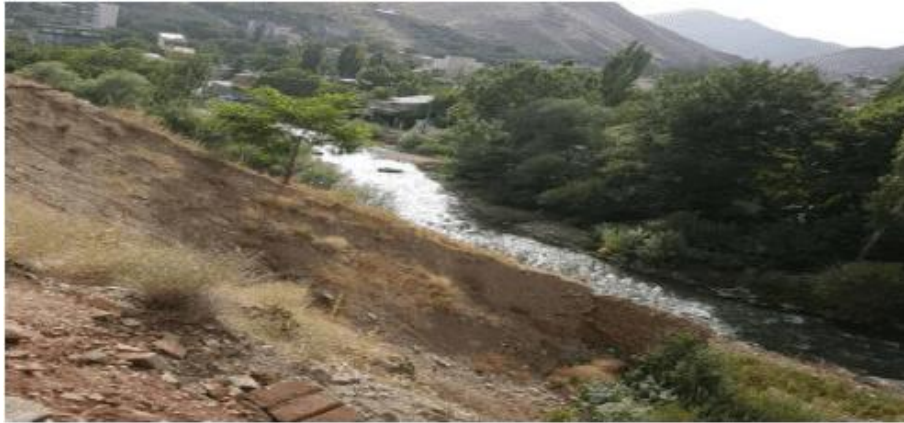
**Figure 6.** Existence of a steep slope along the river in interval 3.

This river is partially limited. In some parts of the river, it is connected to the riverbank on both sides. Its pattern is of the ditch meander type. The communication road is located along the river, which has led to the formation of recreational and private areas around the river. In some parts, the river is connected to the slope on one side. Its bed is covered with rubble, which in some parts are located longitudinally and laterally along the river. Its morphology is platform and rising water. Its width varies from 2.5 to 7 meters. C-adjustment indices in this interval were of severe type. Its MQI is 0.43, which is in a weak position (Figures 6 and 7).

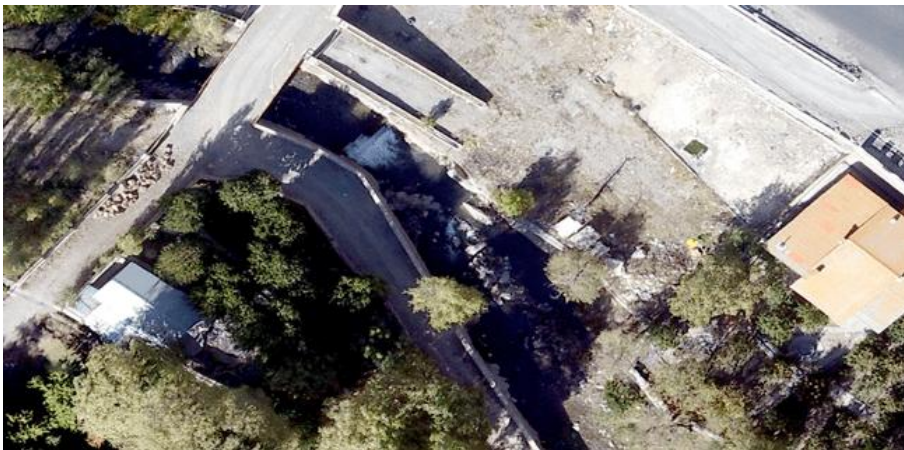
**Figure 7.** Existence of obstacles in the river in interval 3.

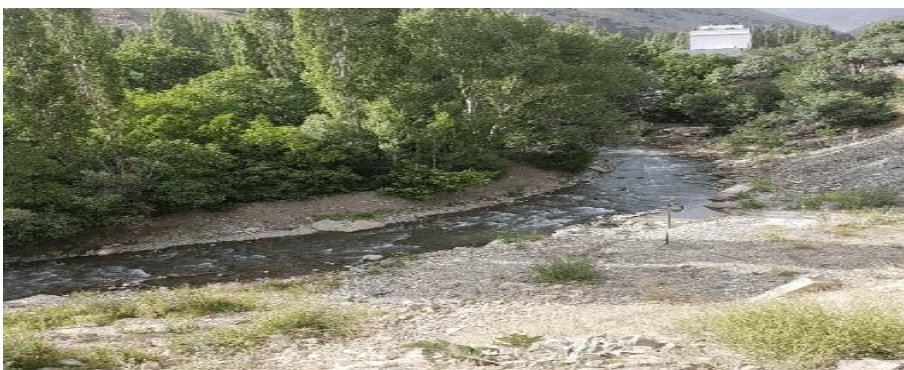
**Figure 8.** Existence of rising water in the course of river water in interval 4.

The bed of this river is rubble and sand. The width of the river varies from 3 to 8 meters. Its pattern is regular spiral meanders. Longitudinal and lateral barriers are seen within the canal. On both sides of the river are residential areas that are mostly villages. Platforms and risers are observed along the canal (Figures 8-10).

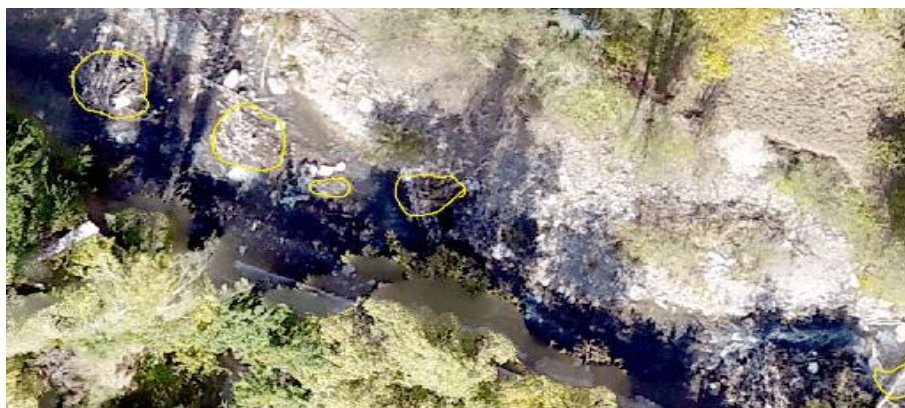
**Figure 9.** Existence of timber obstacles in the river water path in interval 4.

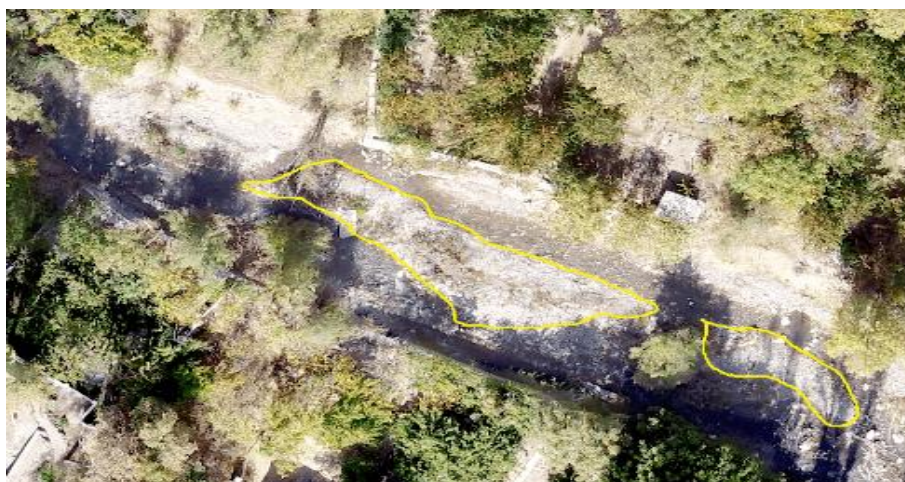
**Figure 10.** Existence of longitudinal obstacles and two-way river in interval 4.

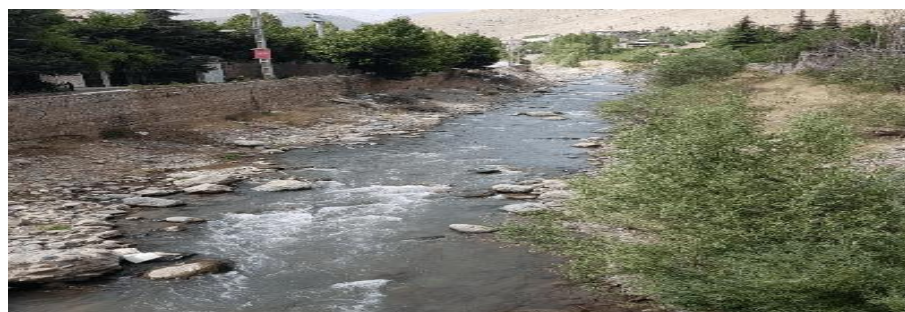
**Figure 12.** Existence of rubbles and rising water along the river in interval 5.

This river passes by Fasham. Its pattern is irregular sinuity. Its morphology is platform, mold and water, and shapes such as longitudinal sedimentary barriers and lateral barriers are also observed within the canal. The height of this range is about 1950 to 1900 meters. Its average slope is 4.8 degrees. In most parts, the river is connected to the riverbank on one side. There are several timber obstacles along the river. As well as numerous transverse structures that have been constructed on the river. In this period, like the other three periods, several residential areas can be seen on both sides of the river. This has changed the shape of the river in some parts. During this period, the branch overflows to it. This range is equal to 0.39 which is in a weak position. In other words, the amount of changes has been high during this period.

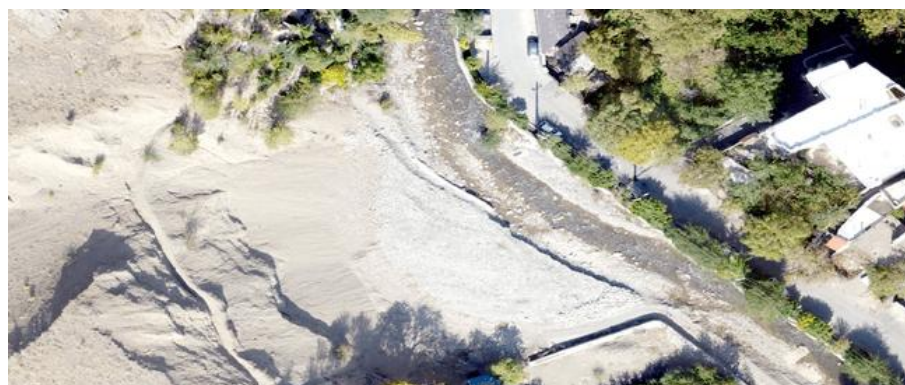
**Figure 13.** View of the river in interval 5 and unstable slopes along the river.

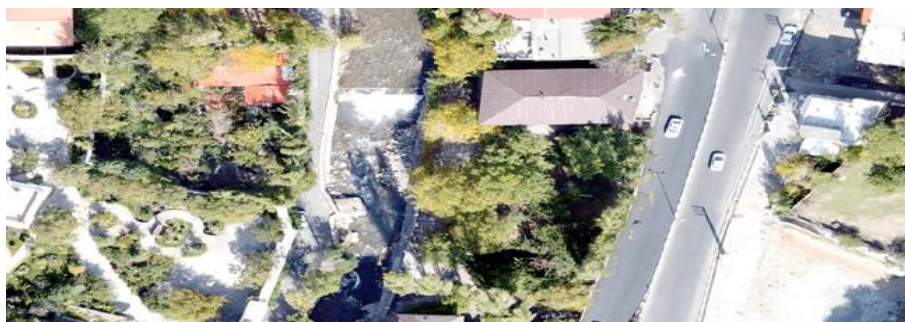
**Figure 14.** Manipulation in the river channel in interval 5.

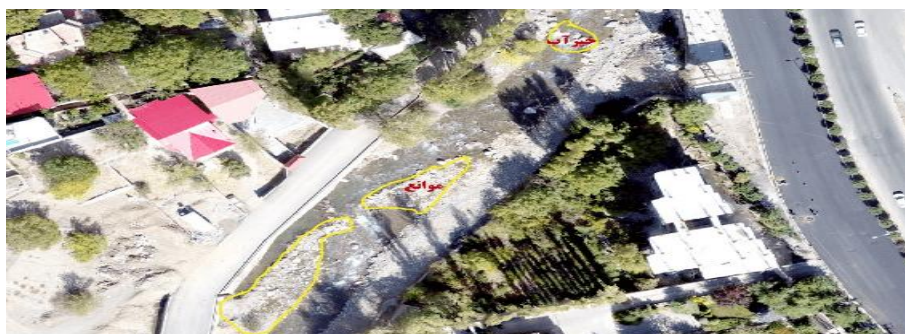
**Figure 15.** Existence of water bumps and obstacles in the river route in interval 6.

is 1888 meters. Its morphology is platform and fast water. Longitudinal and lateral barriers can be seen inside the canal, which in most places blocks the river. The amount of vegetation in this period has decreased compared to other periods. There have been many changes during this period.

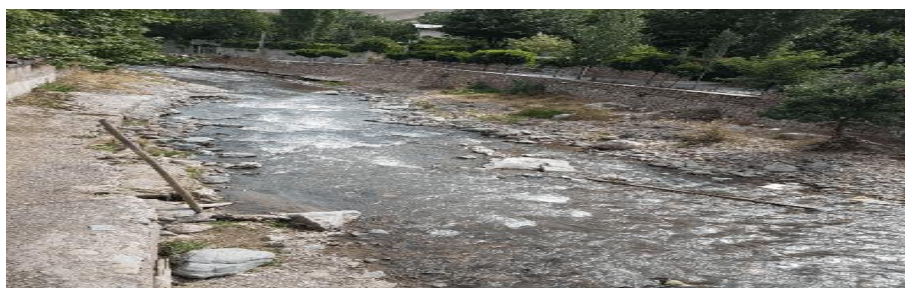
**Figure 16.** Existence of wooden barriers in interval 6.

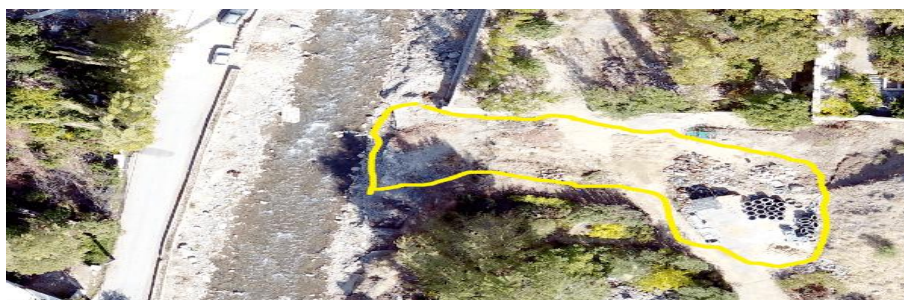
**Figure 18.** Sand harvesting in interval 7.

Figure 18 shows sand extraction in Reach 7, a specific human impact. This action adds to a moderate artificiality score (A11: 3), though its impact is not as severe as the extensive structural modifications (e.g., embankments,

transverse structures) observed in other areas. Pan et al. (2016) propose that localized resource extraction, such as sand harvesting, can harm river ecosystems but tends to have a less severe effect than extensive urban development or channelization. The largely unaltered vegetation in Reach 7 (F12: 3, F13: 0) enhances its average state, since vegetation reinforces banks and sustains ecological connectivity (Rinaldi et al., 2017).

The findings in Table 4 and Figures 17 and 18 emphasize the necessity for focused restoration initiatives in the Jajrood River. The unfavorable to extremely unfavorable conditions in Reaches 1, 3, 4, 5, and 6 arise from human-made structures and alterations in land use that interfere with longitudinal and lateral continuity (Lemay et al., 2021). Eliminating or reducing unnecessary features, like culverts or bank reinforcements, might reestablish natural flow and sediment processes. Reach 7, in its almost natural condition, serves as a blueprint for rehabilitation in other reaches. Reach 2's typical state, despite various human modifications such as artificial canals, indicates a possibility for rejuvenation, as highlighted by Fryirs and Brierley (2000) in their study on river restoration.
